Archaeological Technician Training Kaho'olawe Practicum Report

Prepared by
Kelley Lehuakeaopuna Uyeoka,
Katie Kamelamela
and
Hallett H. Hammatt, Ph.D.

Cultural Surveys Hawaiʻi, Inc. Kailua, Hawaiʻi (Job Code: KAHOOLAWE 1)

September 2009

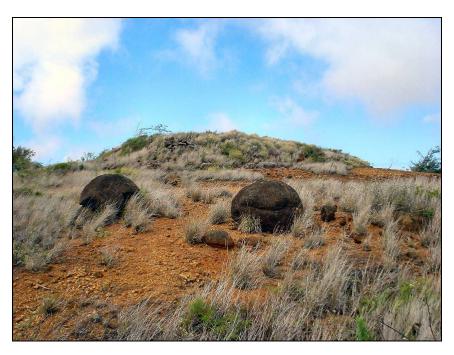
Figure 3. Ka Piko o Wākea site, north side of hummock

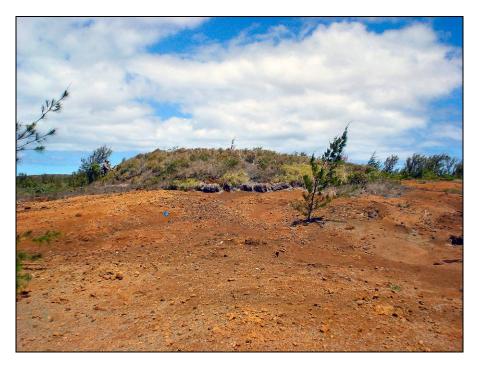
Figure 4. Ka Piko o Wākea site, east side of hummock

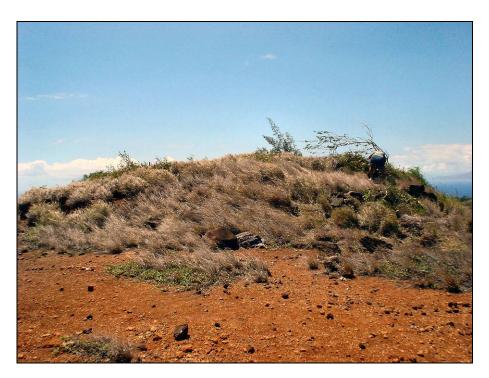
Figure 5. Ka Piko o Wākea site, southwest side of hummock

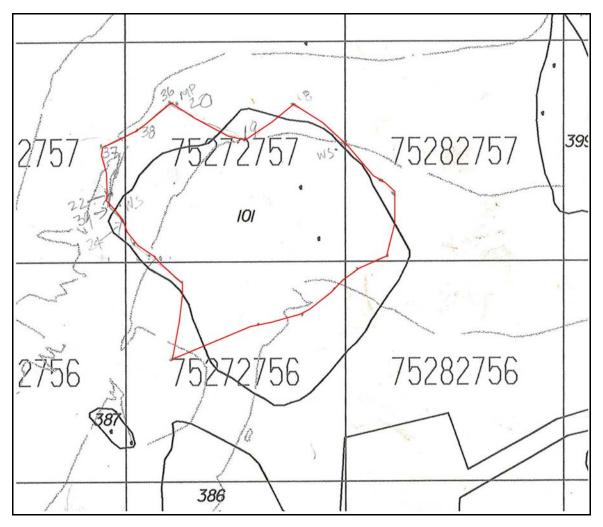
Overall, there appears to be active downslope erosion of the cultural material associated with Ka Piko o Wākea. This downslope migration, illustrated by the difference in the site boundary recorded in 1998 versus that which was recorded in 2009 (Figure 6), is potentially due to sheet erosion during the winter rain season along with the natural progression of soil erosion. It should also be noted, that the southeastern extent of the historic property, as recorded in 1998 has been recently re-planted and may account for some of the shift in the southern site boundary.

Figure 6. Ka Piko O Wākea (Site 101) showing boundary extent as documented in 1998 (black line) and current boundary extent (red line).

It is clear that water runoff and soil erosion at Ka Piko o Wākea is playing a significant role in the downslope migration of cultural materials and presents major potential for further degradation of the intact soils and cultural deposits within the hummock. Erosion threats notwithstanding, there is still some time to study the rate of erosion with the data presented above and develop an effective site stabilization plan. The National Clearinghouse for Archaeological Site Stabilization (http://www.nps.gov/seac/stabil-clearinghouse.htm) may provide a good start for determining which method of erosion control and site stabilization would be appropriate for Kahoʻolawe and Ka Piko o Wākea.

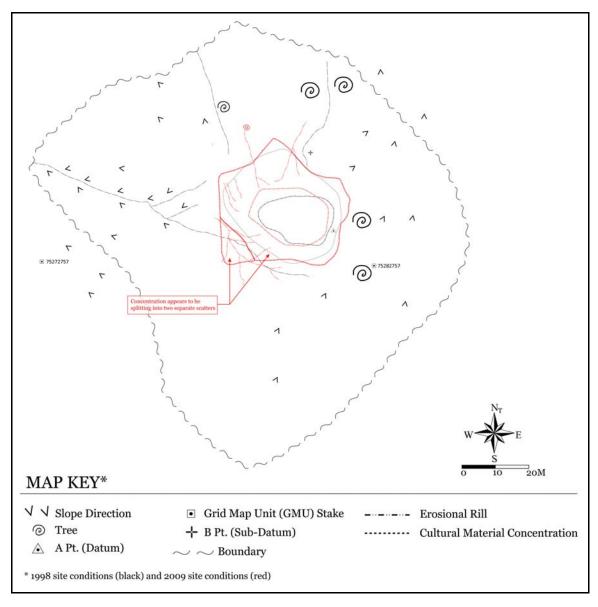
The advancement of soil erosion within the site boundary is best illustrated by the development of new rills that are continuing to progress upslope toward the base of the hummock. During the course of this field work, we were able to more accurately map the location and extent of the hummock feature of Ka Piko O Wākea and have determined that many of the rills and continued headwall erosion would present a threat to the westernmost extent of this feature (Figure 7). Such erosion would potentially compromise any intact cultural deposits within this portion of the hummock.

Figure 7. Plan view of Ka Piko O Wākea focusing on horizontal shifts of the cultural material concentration surrounding the hummock feature and current conditions of the natural landscape (after Hammatt, et al. 1999).

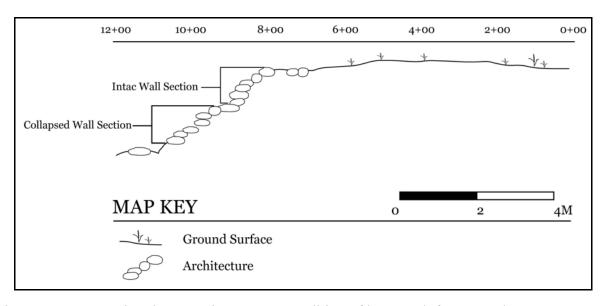
The eastern portion of the hummock and remnant architecture appears to be fairly stable (Figure 8). Given the accumulation of Aeolian (or windblown) deposits on top of the western portion of the hummock, it appears that the intact architecture of Ka Piko O Wākea may have played some role in the stabilization of the soils within this feature.

Figure 8. Cross-section documenting current condition of hummock feature and remnant architecture.

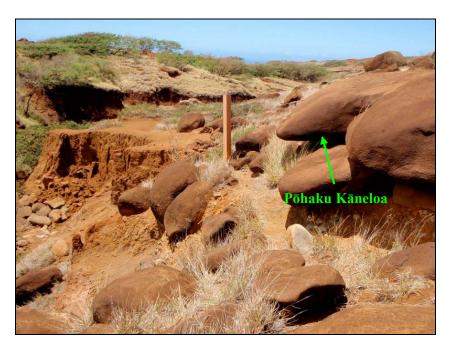
Figure 11. Pōhaku Kāneloa and carsonite marker located directly above gulch. View to the southwest.

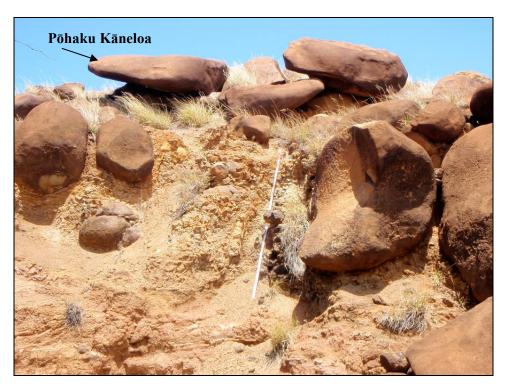
Figure 12. Pōhaku Kāneloa as viewed from the gulch. View to the southwest.

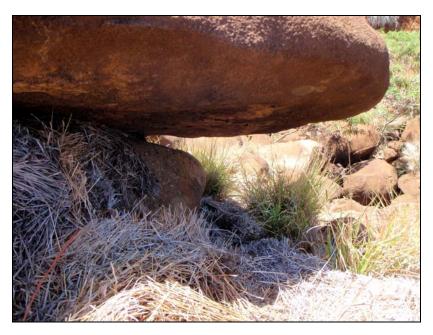
As observed during the field survey and mapping exercises, the affects of water run off and soil erosion have severely impacted the Kāneloa site. The $p\bar{o}haku$ Kāneloa is slipping closer towards the gulch and a portion of the $p\bar{o}haku$ is not secured on stable ground. Erosion control and stabilization of the $p\bar{o}haku$ Kāneloa should be dealt with immediately. It is strongly recommend that the $p\bar{o}haku$ Kāneloa remain in its current location and that all efforts be made to secure its position.

Figure 35. Unstable conditions of the *pōhaku* Kāneloa. Note- the gulch is located directly to the right of the *pōhaku*
