Kahoʻolawe Island Reserve Commission

DOH IV Restoration Status Update (Period Covered November 2018 to June 2019)

Dryland Forest Restoration Project Status Update

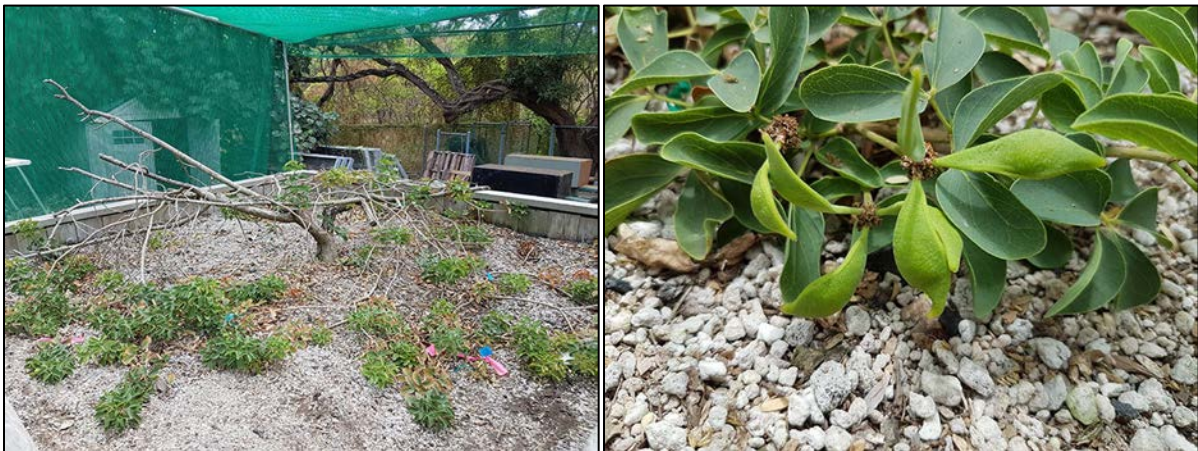
The one at MNBG has been in decline but is producing seed pods (Figure 1). These pods will be harvested and sent to Lyon Arboretum's Micropropagation Lab.

Seed pod development on MNBG plant

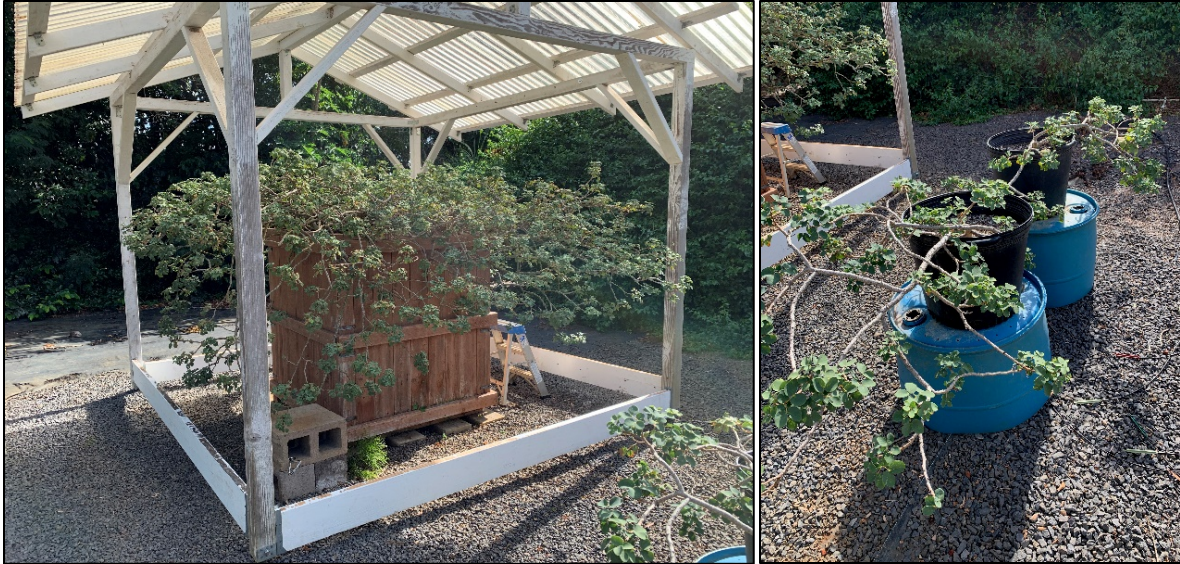
The three plants at Hoʻolawa Farms consist of one large plant and two medium sized cuttings (Figure 2). In June a seed pod from this plant was sent to Lyon Arboretum's Micropropagation Lab and was excised but unfortunately was found to be decayed and rotten.

One large and two medium sized cuttings at Ho'olawa Farms

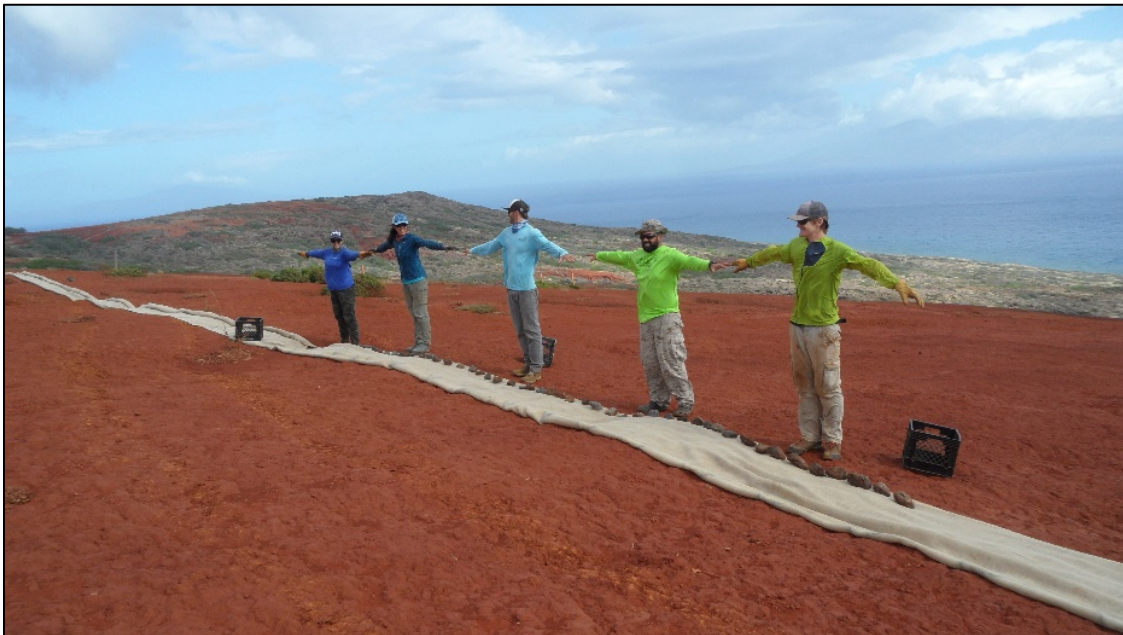
Volunteers rolling up a *wattle* with burlap fabric and rocks

The purpose of the Year 1 of this DOH Project is to reduce the Non-Point Source Pollutant “Excessive Sedimentation” along with habitat restoration in Hakioawa Watershed. In August 2018 work began in the 15ha (37A) Project Site. From November 2018, to June 2019, 188 volunteers have contributed 2,880 hours of time to help with *wattle* construction and outplantings of native grasses and shrubs. Located in Tier I (surface cleared) 8,391 plants (of 10,000 total) have been placed in corridors built along the contours of the landscape. Burlap fabric is laid out and rocks, and or gravel are placed into the wattle and then rolled up. A combination of native reclaimed soil, Black Gold potting mix and Sunshine Mix #4, is spread above the wattle as a raised soil bed for the plants, and irrigation lines are laid out for the delivery of water. *Gabions* (geotextile baskets filled with rocks to act as check dams) have been constructed in the Project Site and have begun to capture soil after rains.

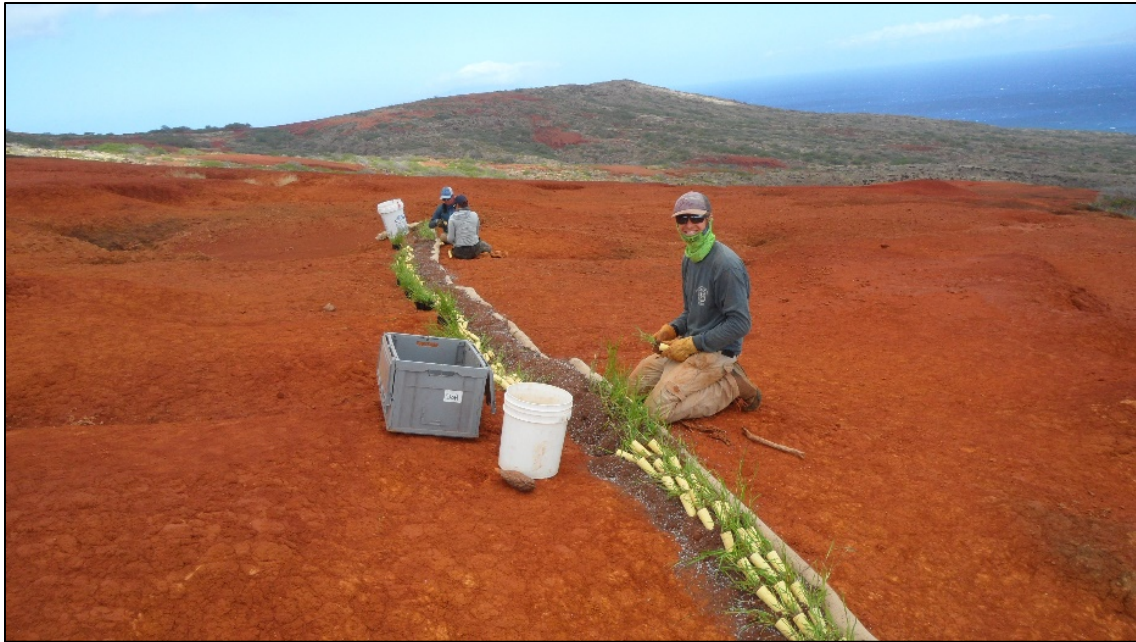
Planting pili grass in the soil mixture in the *wattle* corridor

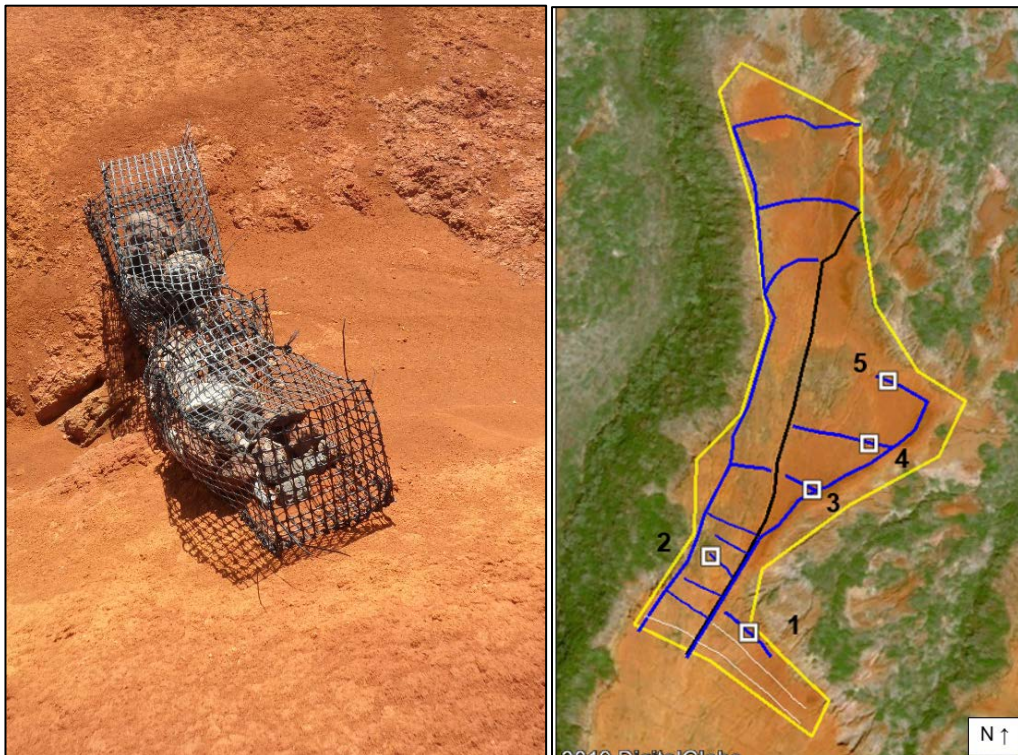
LEFT: Gabion capturing sediment after a rain event. **RIGHT:** Map of Project Site wattles (blue) and planting corridors along contours and five vegetation plots (white squares).

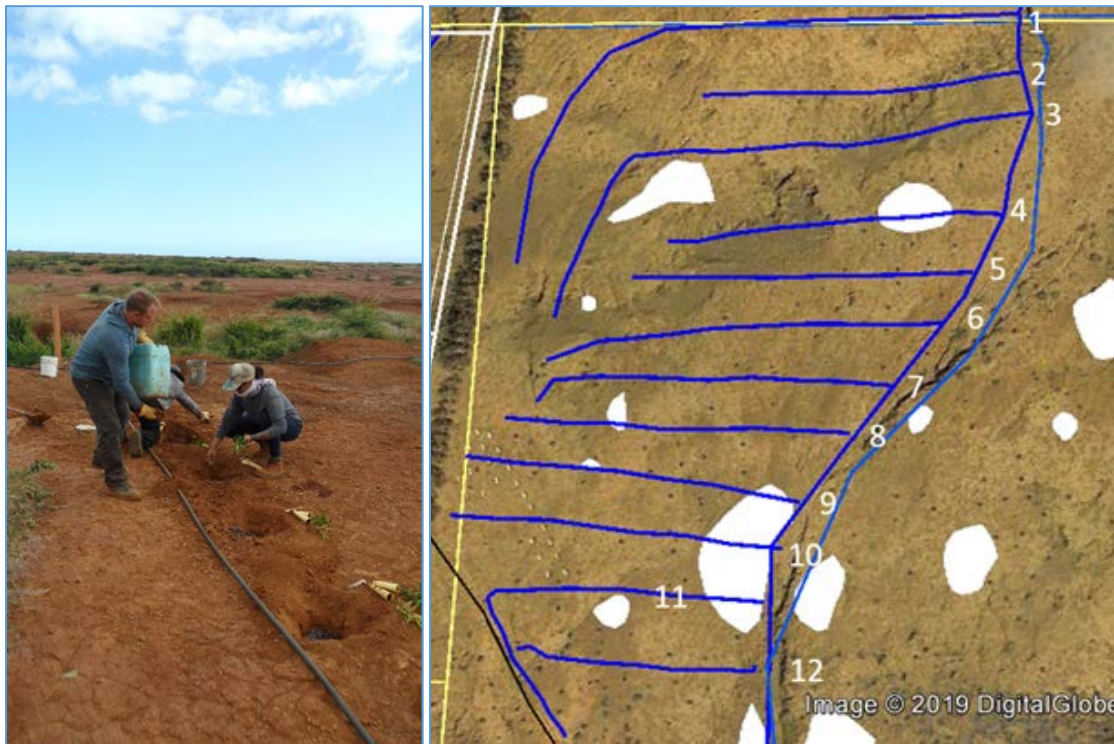
Planting along Line 1 in the Project Site and map of irrigation lines (blue) in Zone A of the 25 acre Project Site. White areas are archaeological sites.

The CIP Dryland Forest Project was designed to outplant 14,800 native shrubs, trees, and grasses in Kamōhio Watershed to establish native plants and help mitigate soil erosion. From November 2018 to June 2019 a total of 12,500 native plants have been placed along 12 irrigation lines in a 10ha (25A) Project Site. A 1.5" main line was brought 0.8 miles from Tanks 1 and 2, to feed the irrigation lines totaling 2100m (6900 feet) in length. Plants were placed in holes dug with an auger every 1m with fertilizer and kiawe mulch. Another 14,800 plants will be placed on irrigation in a second 10ha (25A) section of the Dryland Forest Project Site beginning in Fall 2019.
