1. RESTORATION SUMMARY

DOH 4 Restoration Status Update for Commission Mtg (Period Covered November 2018 to May 2019)

CIP Restoration Project Status Update

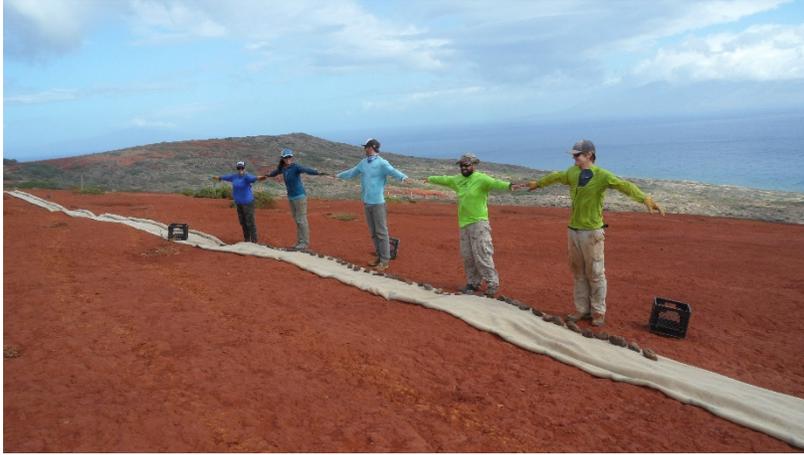
Volunteers rolling up a *wattle* with burlap fabric and rocks

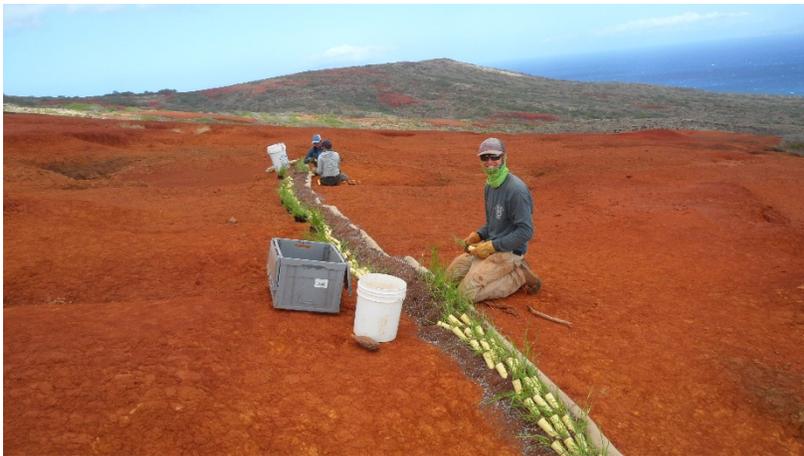
Planting pili grass in the soil mixture in the *wattle* corridor

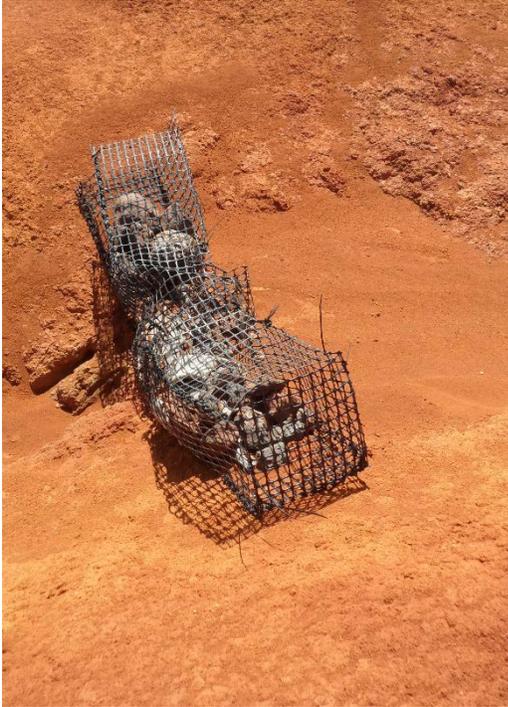
Gabion capturing sediment after a rain event

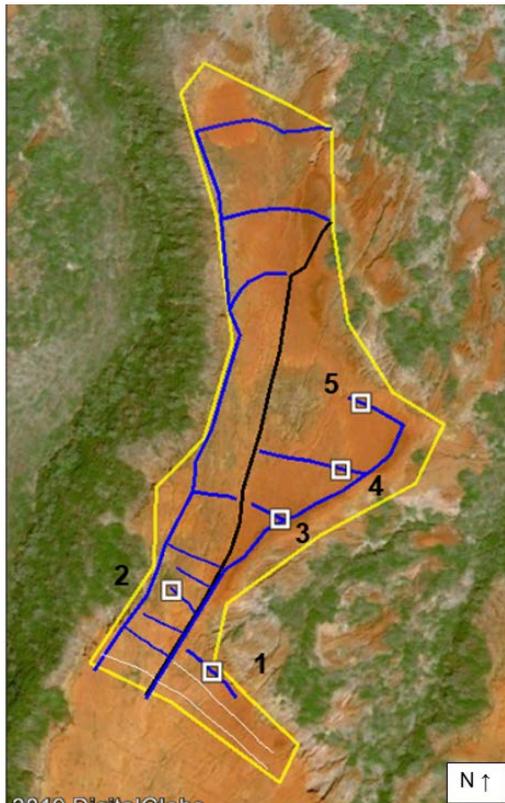
Map of Project Site wattles (blue) and planting corridors along contours and five vegetation plots (white squares).

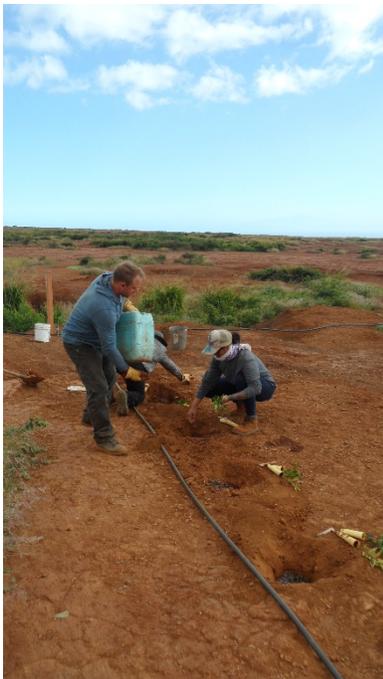
Planting along Line 1 in the Project Site area

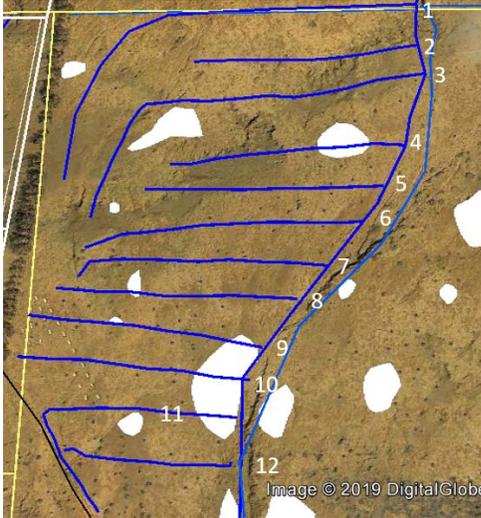
Map of Irrigation Lines (blue) in Zone A of the 25A Project Site
