Archaeological Technician Training Kaho'olawe Practicum Report

Prepared by
Kelley Lehuakeaopuna Uyeoka,
Katie Kamelamela
and
Hallett H. Hammatt, Ph.D.

Cultural Surveys Hawaiʻi, Inc. Kailua, Hawaiʻi (Job Code: KAHOOLAWE 1)

September 2009

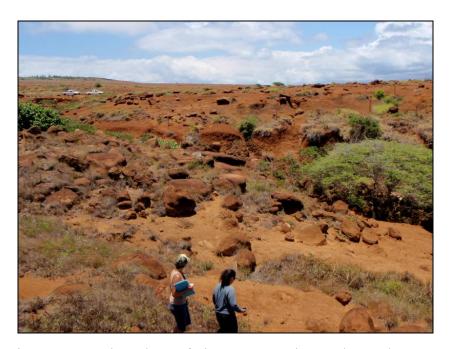
Figure 9. Overview photo of Site 110-BU. View to the northeast.

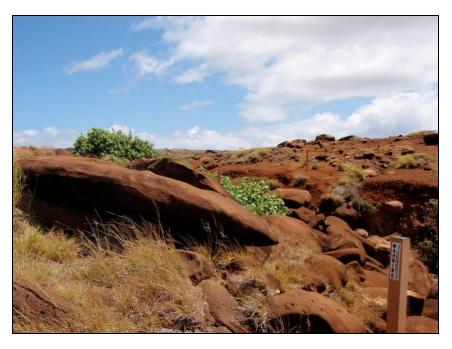
Figure 10. Profile shot of pōhaku Kāneloa. View to the northeast.

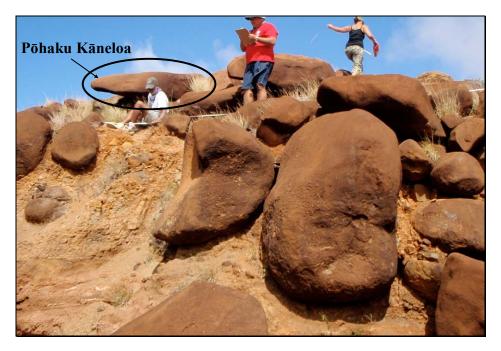
Figure 13. Mapping of site 110-BU. Photo taken from in the gulch, view to the west.

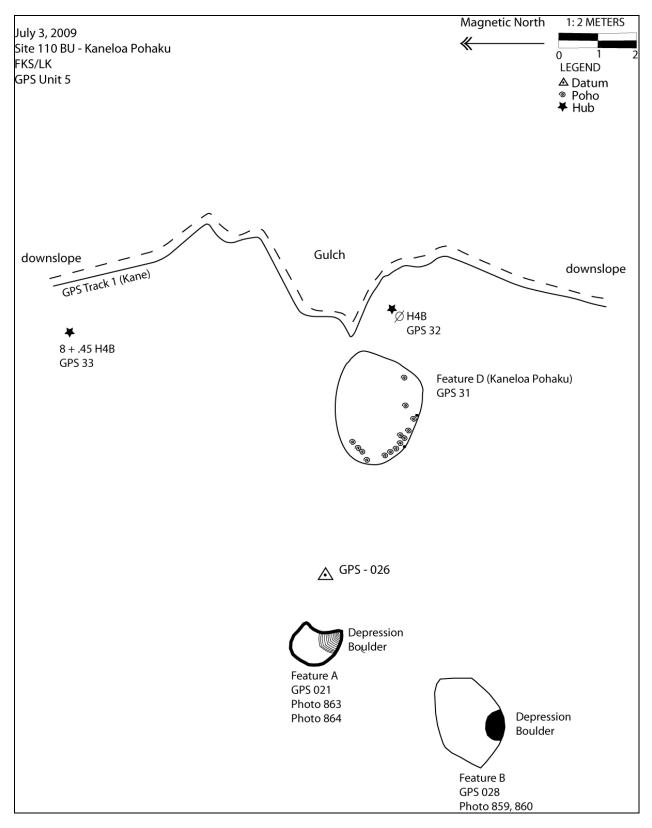
Figure 14. Map of Site 110-BU, the *pōhaku* Kāneloa and surrounding features

Site 110-BU consists of three features, one previously identified feature and two new features. Feature D (Figures18-21), the *pōhaku* Kāneloa, was previously identified and recorded. The two newly identified features are Feature A (Figures15-16) and Feature B (Figures17), two pōhaku with a possible human-made depressions.

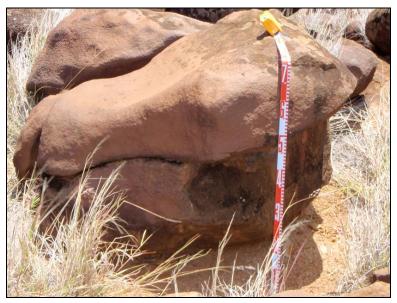
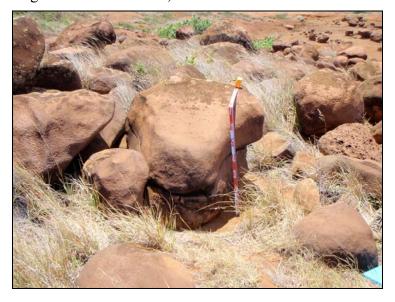
Feature A, a boulder with a large depression located on its southern side was noted as a possible feature. The boulder measures 1.2 meters in length and 0.9 meters in width.

Figure 15. Site 110-BU, Feature A. View to the west.

Figure 16. Site 110-BU, Feature A. View to the northwest.

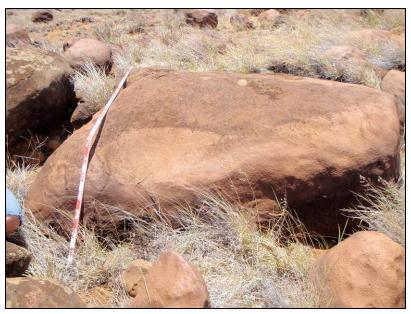
Feature B, a large boulder with a deep depression on its southern side was noted as another possible feature. The boulder measures 2.2 meters in length and 1.8 meters in width.

Figure 17. Site 110-BU, Feature B. View to the northwest.

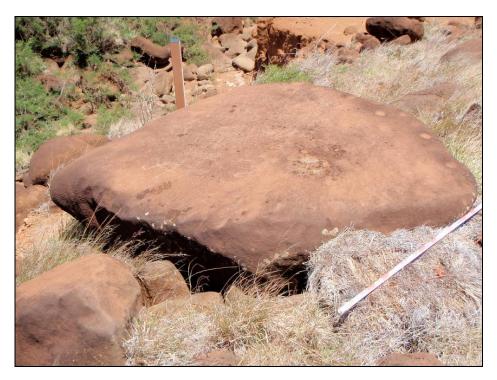
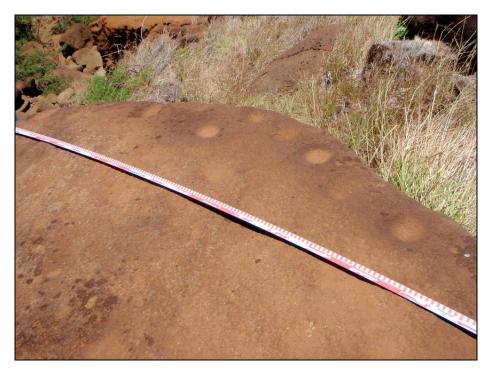
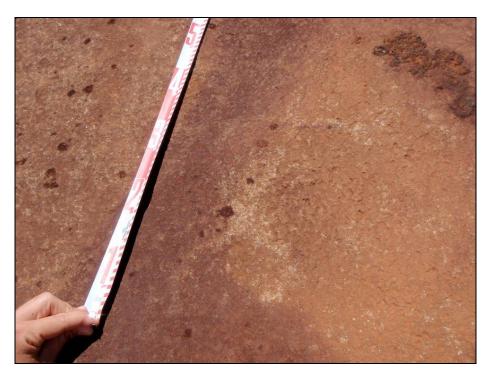
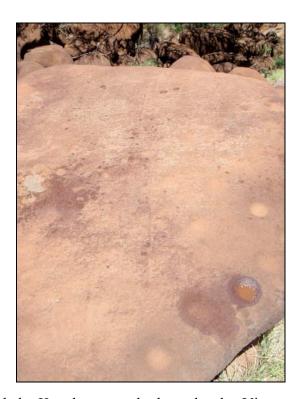
Feature D consists of a large flat boulder, referred to as the pōhaku Kāneloa. The boulder contains three petroglyphs, and 25 human-made depressions, or *poho*, pecked into the top surface. At least two of the three petroglyphs located on the pōhaku Kāneloa appear to have a human form and all appear to have been pecked. The boulder measures 3.1 meters in length and 1.7 meters in width and is one in a cluster of boulders located at the edge of a gulch.

Figure 18. Site 110-BU, Feature D. Plan view, view to the south.

Figure 19. Site 110-BU, Feature D, poho depressions. View to the southeast.

Figure 20. Site 110-BU, Feature D. Petroglyph located on pōhaku Kāneloa. View to the west.

Figure 21. Site 110-BU, põhaku Kāneloa petroglyphs and *poho*. View to the southeast.

As observed during the field survey and mapping exercises, the affects of water run off and soil erosion have severely impacted the Kāneloa site. The $p\bar{o}haku$ Kāneloa is slipping closer towards the gulch and a portion of the $p\bar{o}haku$ is not secured on stable ground. Erosion control and stabilization of the $p\bar{o}haku$ Kāneloa should be dealt with immediately. It is strongly recommend that the $p\bar{o}haku$ Kāneloa remain in its current location and that all efforts be made to secure its position.

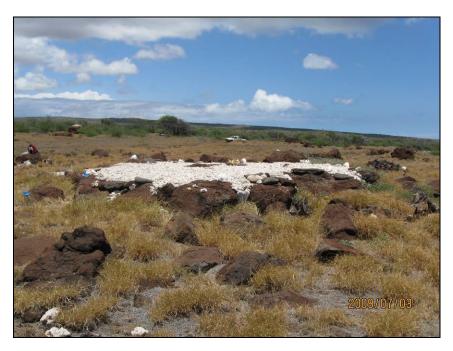
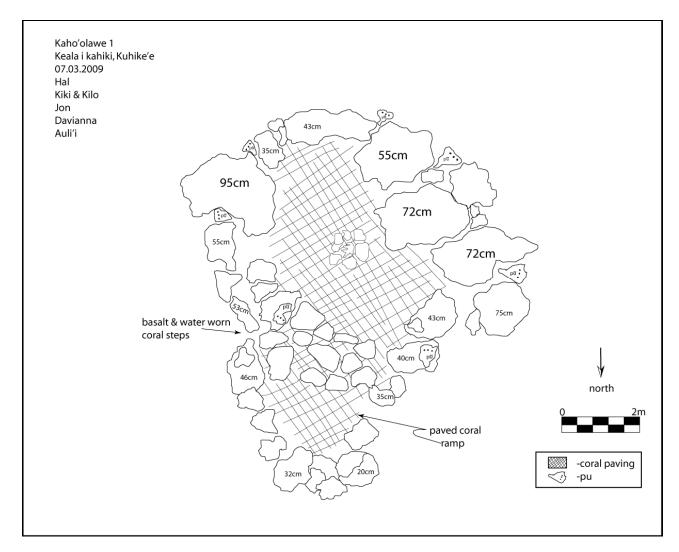
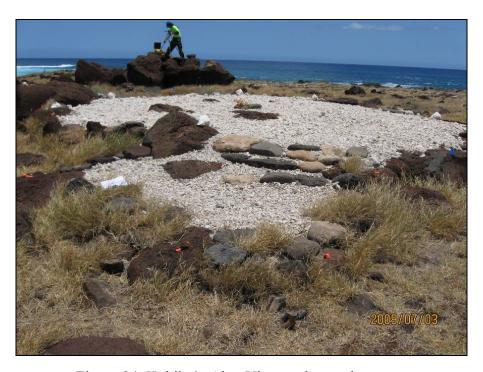
Figure 22. Feature A, Kuhike'e Ahu. View to the southeast

Feature A, known as the Kuhike'e Ahu, is described as a platform with boulder [missing word] built around bedrock with some moved rocks set upright, and surrounding features were surveyed and mapped. The platform was constructed under the direction of Atwood Makanani (*kahu*), member of the Protect Kaho'olawe 'Ohana and Polynesian Voyaging Society, in October 2004.

Figure 23. Kuhike'e Ahu, plan view map.

Figure 24. Kuhike'e Ahu. View to the southwest

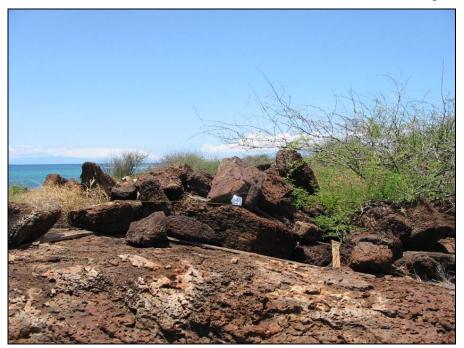
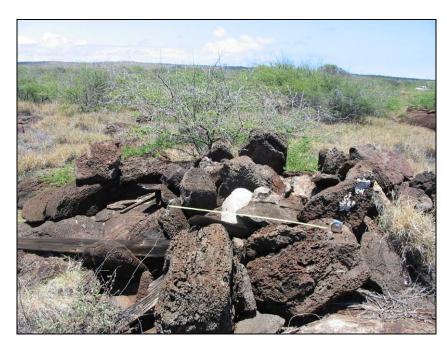
Feature B is an *ahu* on the northern side of Feature A, the Kuhike'e Ahu main platform:

Figure 25. Kealaikahiki site, Feature B, *ahu*. View to the north.

Figure 26. Kealaikahiki site, Feature B showing rock pile and wood. View to the northeast.

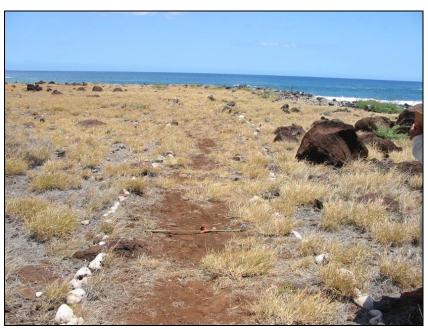
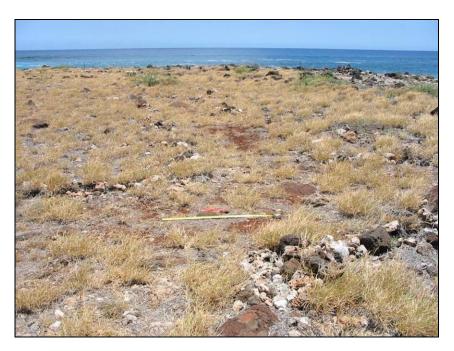
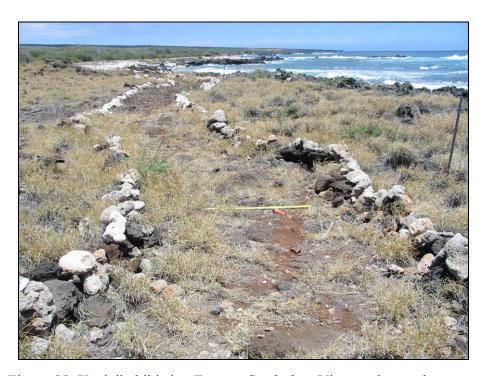
Feature C is a shoreline trail or *ala loa*:

Figure 27. Kealaikahiki site, Feature C, ala loa. View to the southeast.

Figure 28. Kealaikahiki site, Feature C, *ala loa* intersecting with Kuhike'e trail. View to the southeast.

Figure 29. Kealaikahiki site, Feature C, ala loa. View to the southeast.

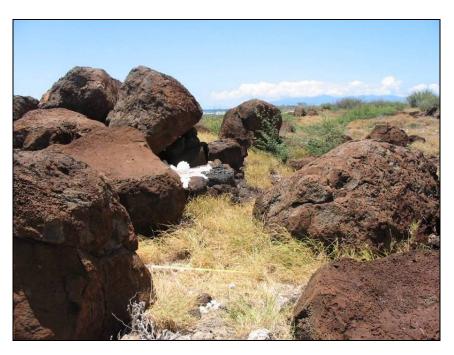
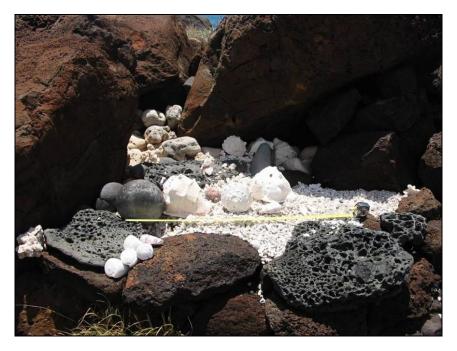
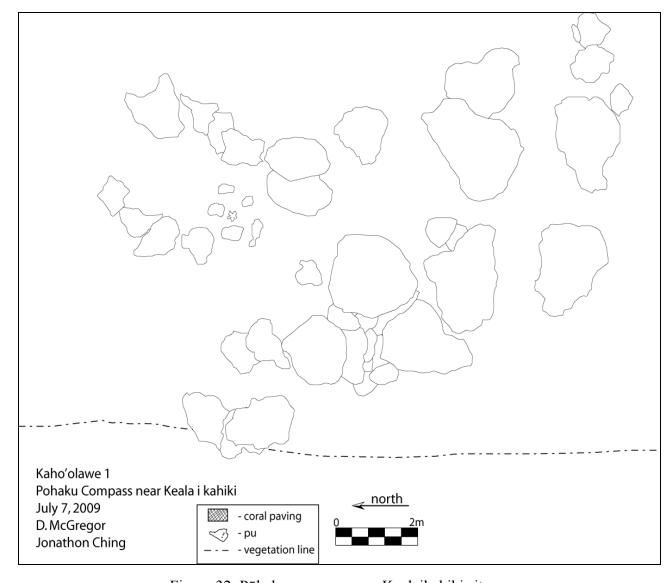
Feature D is a *pōhaku* compass located north of Feature A, the Kuhike'e Ahu:

Figure 30. Kealaikahiki site, Feature D, pōhaku compass. View to the southwest.

Figure 31. Kealaikahiki site, Feature D, *pōhaku* compass. View to the southwest.

Figure 32. Põhaku compass near Kealaikahiki site

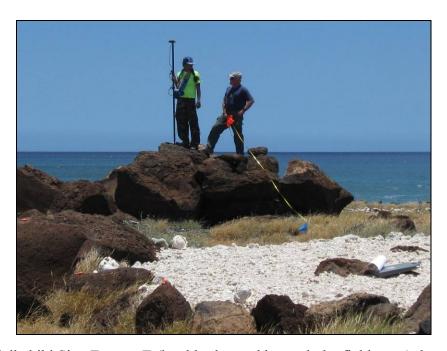
Feature E is an *ahu* on the south side of Feature A, the Kuhike'e Ahu. A wooden stake with a grid and site number was located at this feature:

Figure 33. Kealaikahiki Site, Feature E (boulder located beneath the field crew), located directly to the southwest of Feature A, the Kuhike'e Ahu.

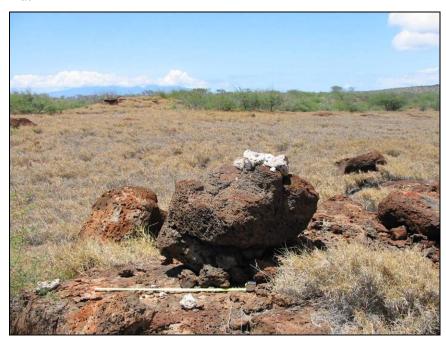
Feature F consists of stacked *pōhaku* and coral. It is located on the north side of Feature A, the Kuhike'e Ahu:

Figure 34. Kealaikahiki site, Feature F. View to the northeast
