1. RESTORATION SUMMARY

October 2018

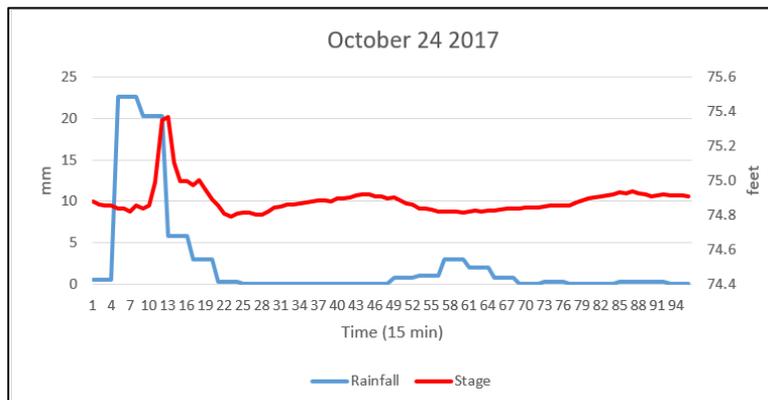
The HOBO® water level logger was retrieved and stream stage (height) data downloaded. There were six main rain events during the one year project and the graph illustrates the first event in October 4, 2017 and corresponding stream stage.

Rainfall and Hakoawa stream stage for October 24 2017

Using this data, discharge in cubic feet per second (cfs) may be calculated for Hakoawa Stream.

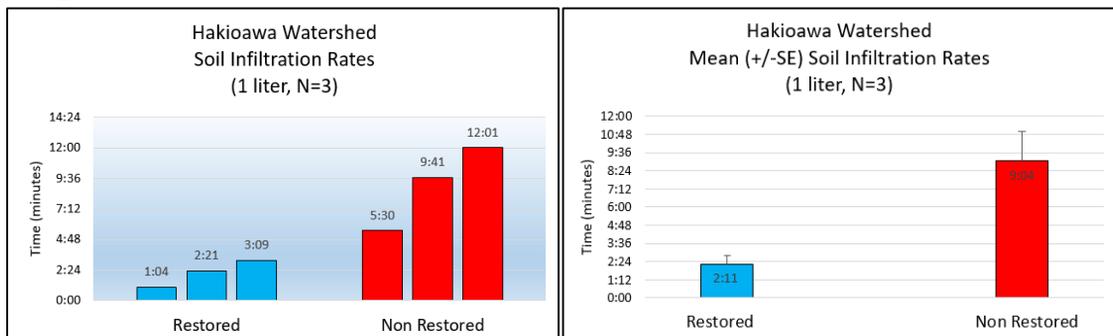
Soil infiltration rates were measured using 1 liter of water (three times) and an 8" PVC pipe in pili (*Heteropogon contortus*) grass (restored) and hard pan soils (non-restored). The preliminary results indicate faster infiltration rates for soils with pili grass (restored) than hardpan soils (non-restored).

The mean infiltration rate was considerably faster in restored soils (2:11 minutes) with pili grass and roots than the hard pan soil (9:04 minutes).

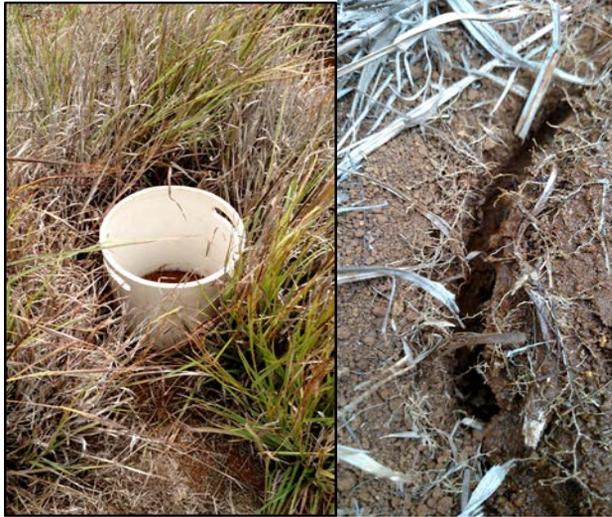
8" PVC pipe measuring soil infiltration in Pili grass (restored). Note roots in soil.

Further soil infiltration measurements may be taken for a better representation of this difference between soils in restored areas with plant roots (acting as micropores in restored areas for faster percolation of water) and more impervious clay like hard pan soils in non-restored areas. The Water Security Advisory Group grant was extended six months from September 2018 through February 2019.

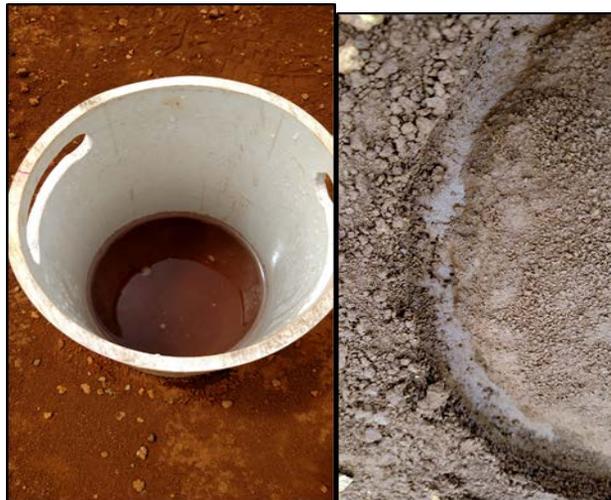
Measuring soil infiltration in hard pan soils (non-restored). Note no roots.
(Photos by James Bruch)
